WL-TR-91-4032
DOT/FAA/CT-91/23
VOL II, Part 2

COMPOSITE FAILURE ANALYSIS HANDBOOK
VOL II - TECHNICAL HANDBOOK
PART 2 - ATLAS OF FRACTOGRAPHS

R.J. Kar
Northrop Corporation
One Northrop Avenue
Hawthorne, California 90250-3277

February 1992

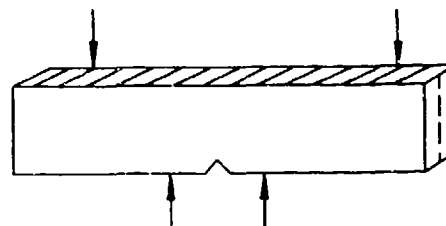
Fracture type	Translaminar mode I compression
Ply layup	[+45, -45] 16S
Test type	Four-point bend
• Test conditions	Dry
• Fiber end fracture	
Material	Hercules 3501-6/177°C cure AS4 fibers

-65°F, dry

180°F, dry

270°F, dry

Figure 2-156. SEM Photographs of Translaminar Mode I Compression, +45/-45 Fracture, -65, 180, 270 F/Dry (20X)

The test matrix for this section is provided in Table 2-6. Figures 2-150 through 2-173 are the translaminar compression fractographs. The reader should note that the low-magnification SEM photomicrographs reveal both compression fracture (flat) and tension fracture (fibers protruding). This is because the flexural nature of the test specimen, where cracking is initiated at the notch in compression. The high magnification photographs are from the compression fracture region. The fractography figures are arranged in the same order that the corresponding tests are listed in Table 2-6.

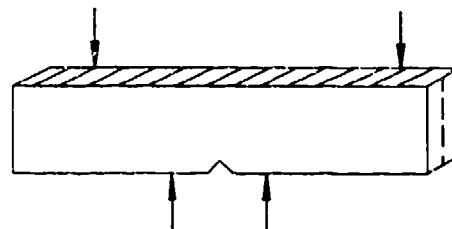
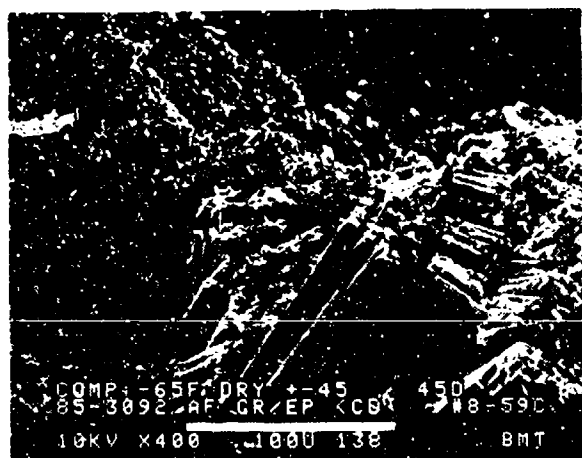
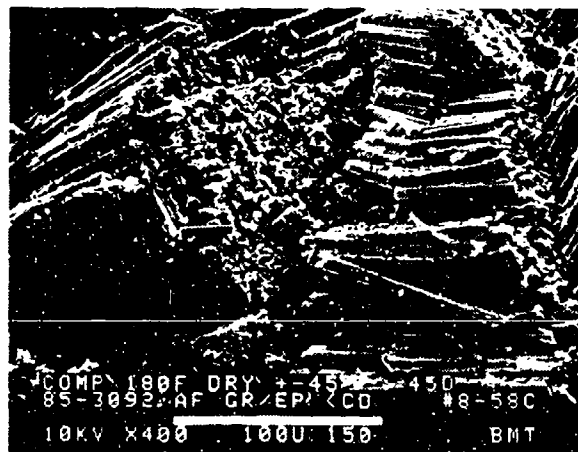
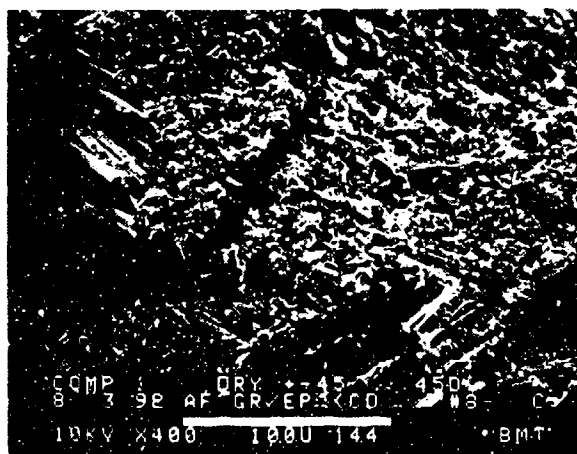
Fracture type	Translaminar mode I compression
Ply layup	[+45, -45] 16S
Test type	Four-point bend
• Test conditions	Dry
• Fiber end fracture	
Material	Hercules 350i-6/177°C cure AS4 fibers

-65°F, dry

180°F, dry

270°F, dry

Figure 2-157. SEM Photographs of Translaminar Mode I Compression, +45/-45 Fracture, -65, 180, 270 F/Dry (400X)

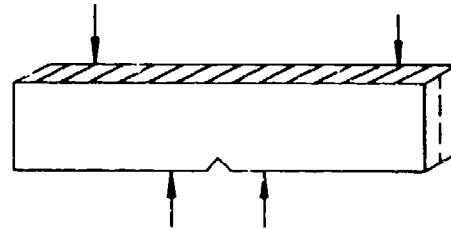
Fracture type	Translaminar mode I compression
Ply layup	[+45, -45] 16S
Test type	Four-point bend
• Test conditions	Wet
• Fiber end fracture	
Material	Hercules 3501-6/177°C cure AS4 fibers

-65°F, wet

180°F, wet

270°F, wet

Figure 2-158. SEM Photographs of Translaminar Mode I Compression, +45/-45 Fracture, 70, 180, 270 F/Wet (20X)

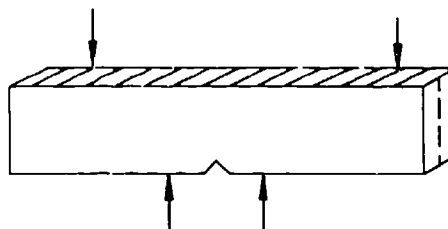
Fracture type	Translaminar mode I compression
Ply layup	[+45, -45] 16S
Test type	Four-point bend
• Test conditions	Dry
• Fiber end fracture	
Material	Hercules 3501-6/177°C cure AS4 fibers

70°F, wet

180°F, wet

270°F, wet

Figure 2-159. SEM Photographs of Translaminar Mode I Compression, +45/-45 Fracture, 70, 180, 270 F/Wet (400X)

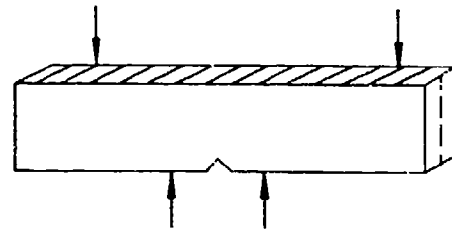
Fracture type	Translaminar mode I compression
Ply layup	[0, 90] 16S
Test type	Four-point bend
• Test conditions	21°C, dry
• Fiber end fracture	
Material	Hercules 3501-G/177°C cure AS4 fibers

← Mechanically induced crack direction

Figure 2-160. SEM Photographs of Translaminar Mode I Compression, 0/90 Fracture, 70 F/Dry

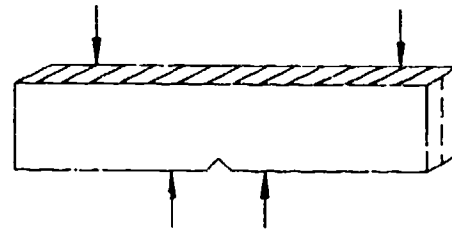
Fracture type	Translaminar mode I compression
Ply layup	[0, 90] _{16S}
Test type	Four-point bend
• Test conditions	Dry
• Fiber end fracture	
Material	Hercules 3501-6/177°C cure AS4 fibers

-65°F, dry

180°F, dry

270°F, dry

Figure 2-161. SEM Photographs of Translaminar Mode I Compression, 0/90 Fracture, -65, 180, 270 F/Dry (20X)

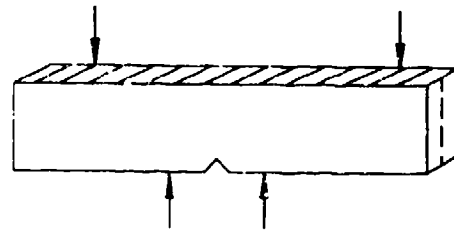
Fracture type	Translaminar mode I compression
Ply layup	[0, 90]16S
Test type	Four-point bend
• Test conditions	Dry
• Fiber end fracture	
Material	Hercules 3501-6/177°C cure AS4 fibers

-65°F, dry

180°F, dry

270°F, dry

Figure 2-152. SEM Photographs of Translaminar Mode I Compression, 0/90 Fracture, -65, 180, 270 F/Dry (400X)

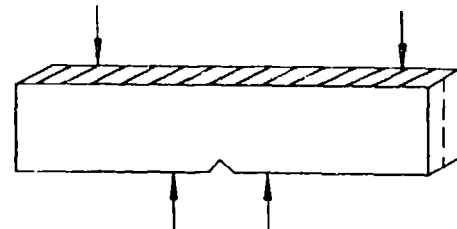
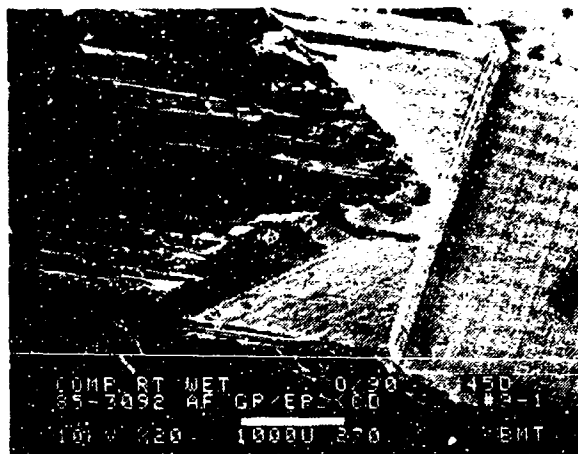
Fracture type	Translaminar mode I compression
Ply layup	{0, 90}16S
Test type	Four-point bend
• Test conditions	Wet
• Fiber end fracture	
Material	Hercules 3501-6/177°C cure AS4 fibers

70°F, wet

Figure 2-163. SEM Photographs of Translaminar Mode I Compression, 0/90 Fracture, 70, 180, 270 F/Wet (20X)

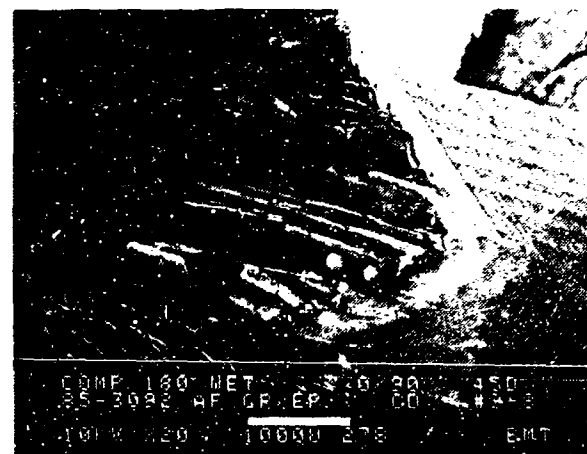
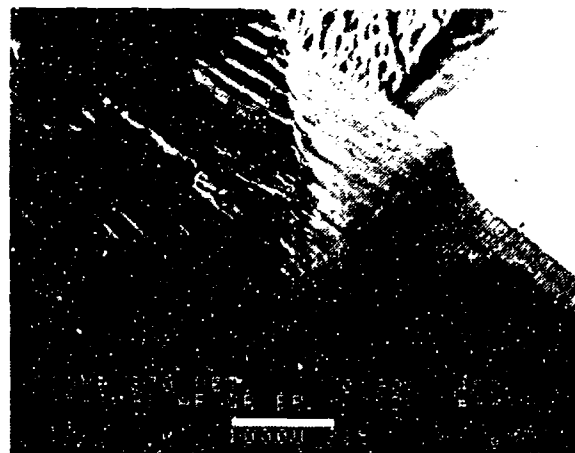
180°F, wet

Mechanically induced crack direction

270°F, wet

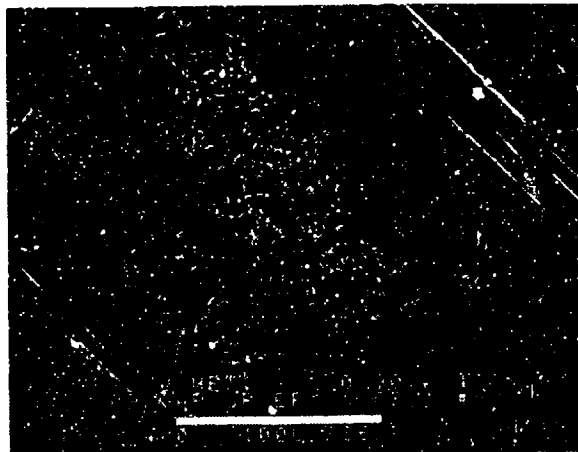
Figure 2-164. SEM Photographs of Translaminar Mode I Compression, 0/90 Fracture, 70, 180, 270 F/Wet (400X)

Fracture type	Translaminar mode I compression
Ply layup	[0, 90] _{16S}
Test type	Four-point bend
• Test conditions	Wet
• Fiber end fracture	
Material	Hercules 3501-6/177°C cure AS4 fibers

70°F, wet

180°F, wet

Mechanically induced crack direction

270°F, wet

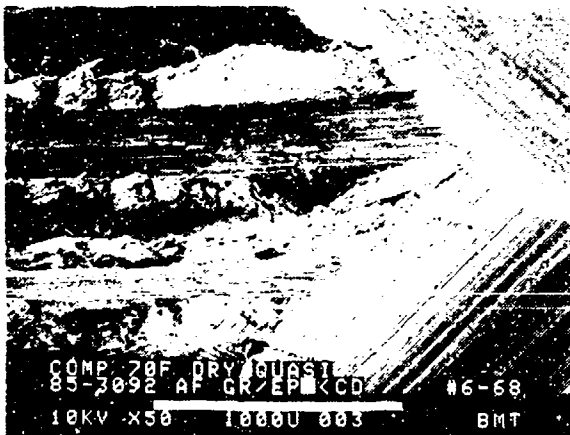
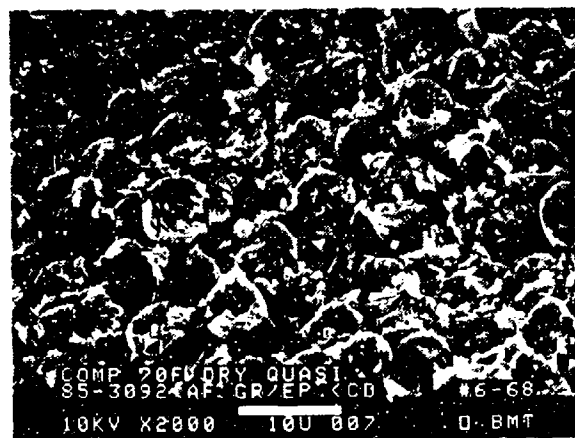
Figure 2-165. SEM Photographs of Translaminar Mode I Compression, 0/45/90 Fracture, 70 F/Dry

Fracture type	Translaminar mode I compression
Ply layup	[0, 45, 90] 16S
Test type	Four-point bend
• Test conditions	21°C, dry
• Fiber end fracture	
Material	Hercules 3501-6/177°C cure AS4 fibers

Mechanically Induced crack direction

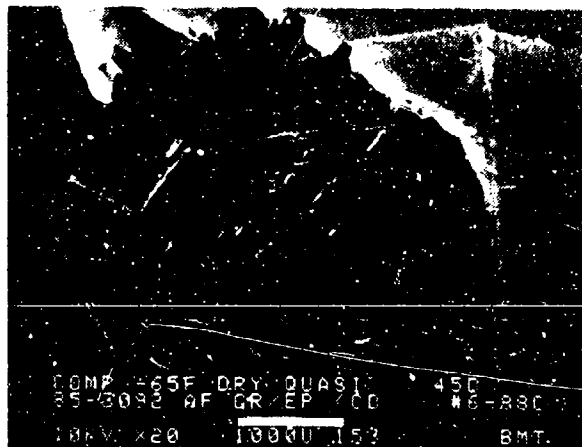
Figure 2-166. SEM Photographs of Translaminar Mode I Compression, 0/45/90 Fracture, -65, 180, 270 F/Dry (20X)

Fracture type	Translaminar mode I compression
Ply layup	[0, 45, 90] _{16S}
Test type	Four-point bend
• Test conditions	Dry
• Fiber end fracture	
Material	Hercules 3501-6/177°C cure AS4 fibers

-65°F, dry

180°F, dry

← Mechanically induced crack direction

270°F, dry

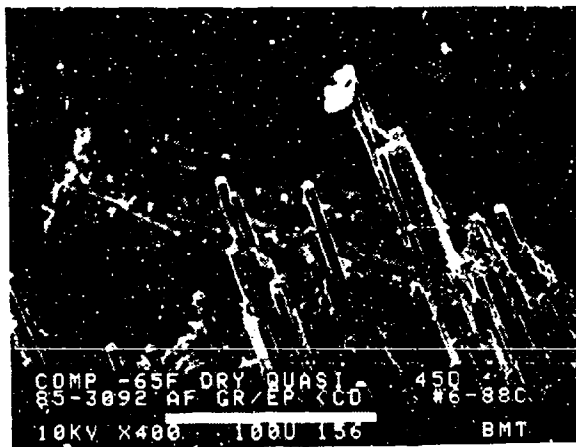
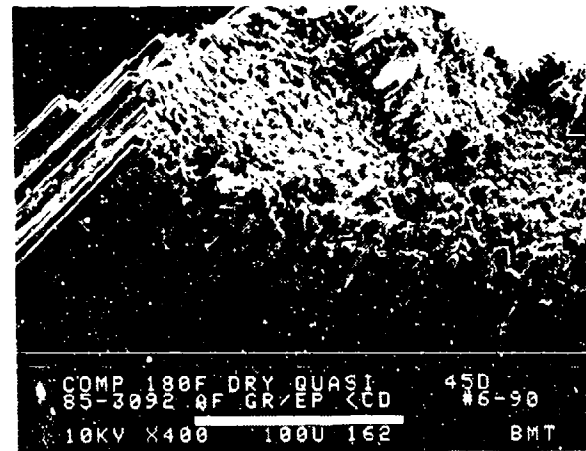
Figure 2-167. SEM Photographs of Translaminar Mode I Compression, 0/45/90 Fracture, -65, 180, 270 F/Dry (400X)

Fracture type	Translaminar mode I compression
Ply layup	[0, 45, 90] _{16S}
Test type	Four-point bend
• Test conditions	Dry
• Fiber end fracture	
Material	Hercules 3501-6/177°C cure AS4 fibers

-65°F, dry

180°F, dry

Mechanically induced crack direction

270°F, dry

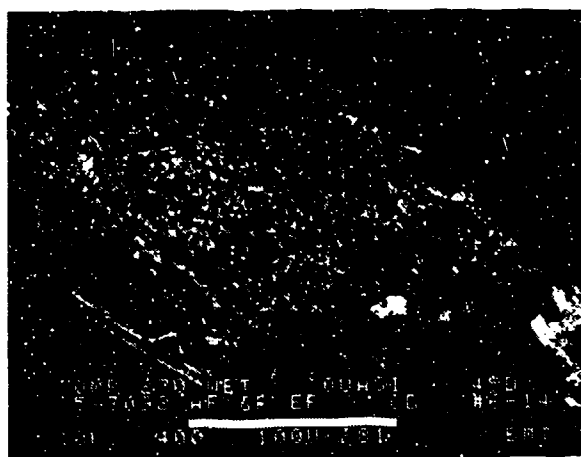
Figure 2-169. SEM Photographs of Translaminar Mode I Compression, 0/45/90 Fracture, 70, 180, 270 F/Wet (400X)

Fracture type	Translaminar mode I compression
Ply layup	[0, 45, 90] _{16S}
Test type	Four-point bend
• Test conditions	Wet
• Fiber end fracture	
Material	Hercules 3501-6/177°C cure AS4 fibers

70°F, wet

180°F, wet

Mechanically induced crack direction

270°F, wet

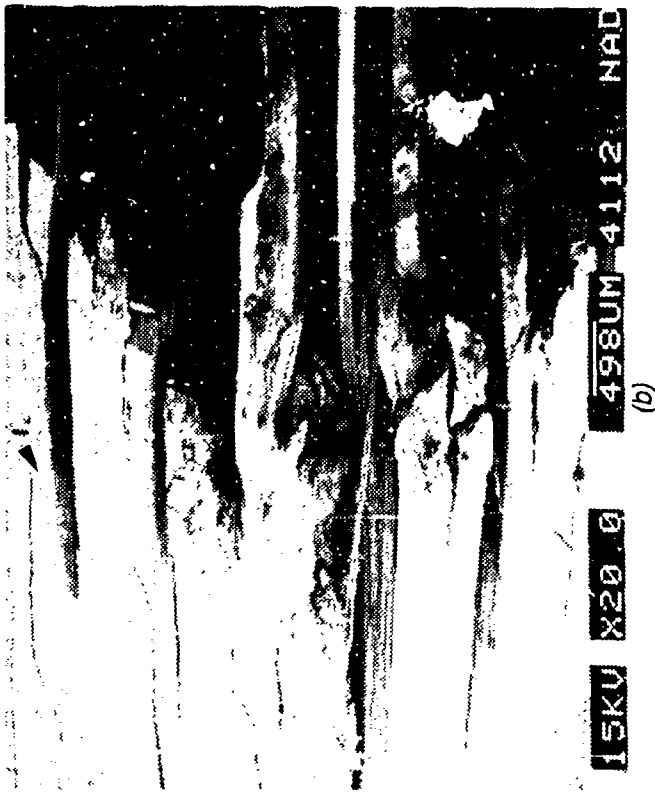
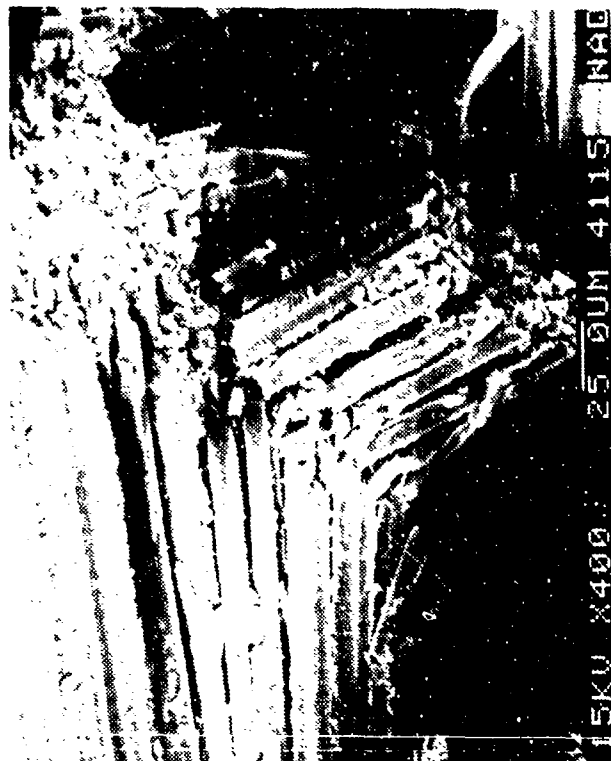
Figure 2-170. Optical and SEM Photographs of Translaminar Mode I Compression Fracture in Impact Damaged Gr/Ep - 32 Ply Quasi-Isotropic

(a) Macro photograph of Fractured Fragments

Note damage zone shown by arrows

(b), (c) Normal and Oblique Views of Fracture Near the Apex

1 = Impact damage

CD = Crack propagation direction

Figure 2-170. (Continued)
 (d) Microbuckling Features (Chop Marks) on Fractured Fiber Ends
 (e) Broken Fibers

CD = Crack-propagation direction

Visual inspection revealed extensive buckling damage around the point of impact. Failure of the panel occurred in a band approximately 1.0 to 1.5 inches wide across the full width of the panel (Figure 2-217). TTU indicated a delamination which was exposed for further examination to determine the mode of failure in the vicinity of the impacted area. An examination was conducted under the optical microscope. In the region immediately surrounding the impact site (0.3 inch in diameter), the features were predominantly hackle formations indicating Mode II shear failure. The outer perimeter of the impact site was predominantly covered with rivermarks and resin microflow indicating Mode I tension failure (Figure 2-218). The crack initiated at the impact site and propagated radially through the specimen from the tool side in both interlaminar and translaminar fracture modes (Figure 2-219). Figure 2-220 shows CAI fractography performed by Boeing on a [0/45/90]_{8s} laminate. Additional CAI test fractography of a [0/45/90]_{8s} Gr/Ep laminate is shown in Figure 2-170.

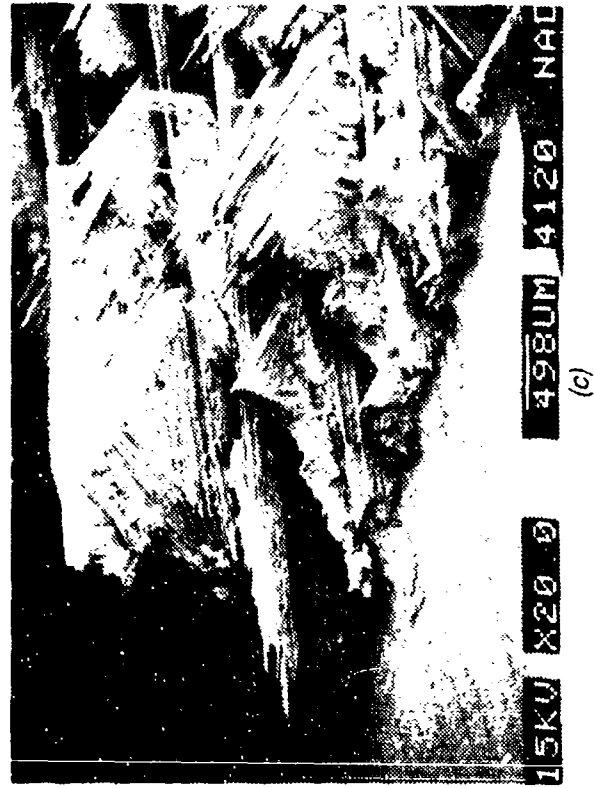
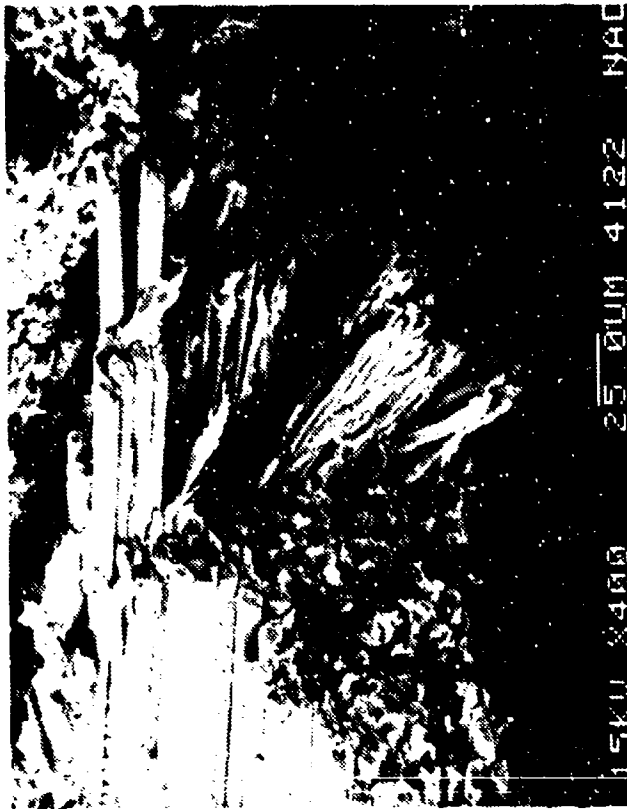
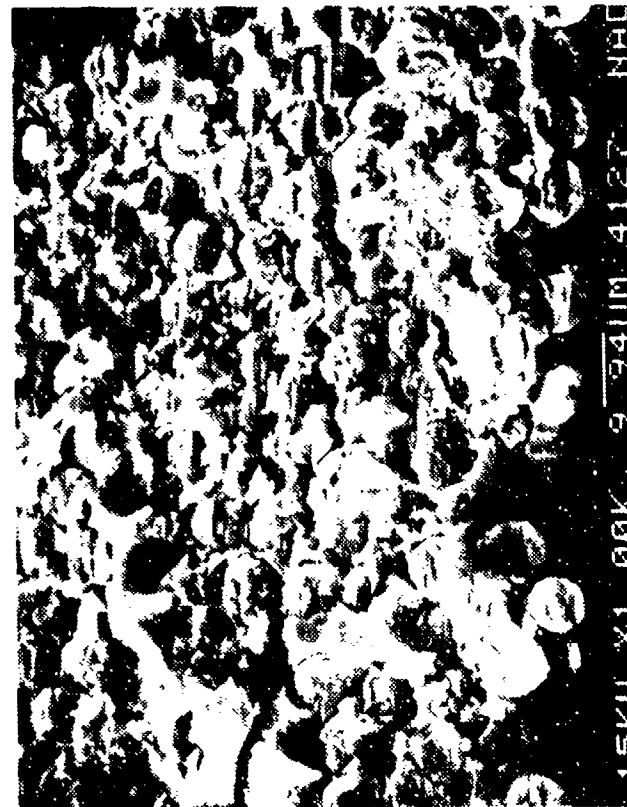
Figure 2-171. Optical and SEM Photographs of Translaminar Mode
I Compression Fracture in Gr/Ep - 32 Ply
Quasi-Isotropic, Water Immersed Before Test
(a) Macro photograph of Fractured Fragments
(b), (c) Normal and Oblique Views of Fracture Near
the Apex

CD = Crack-propagation direction

Figure 2-171. (Continued)
 (d) Microbuckling Features (Chop Marks) on Fractured Fiber Ends
 (e) Broken Fibers
 CD = Crack propagation direction

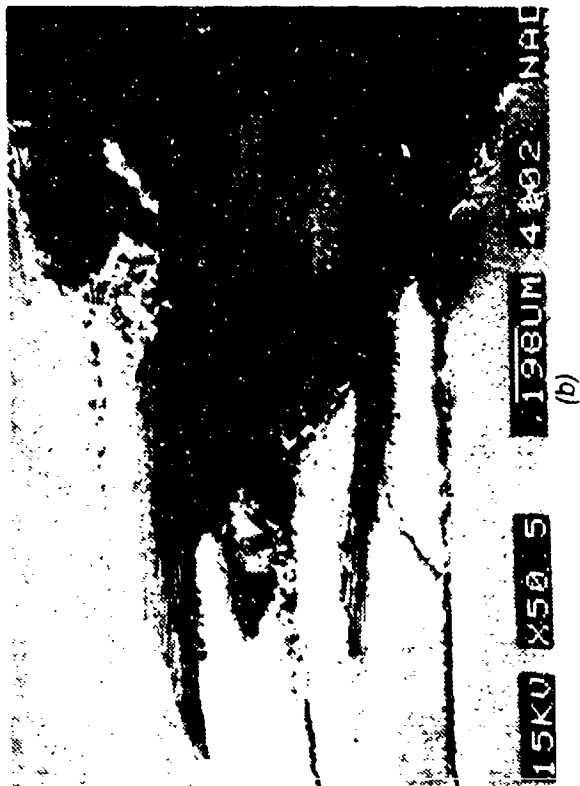
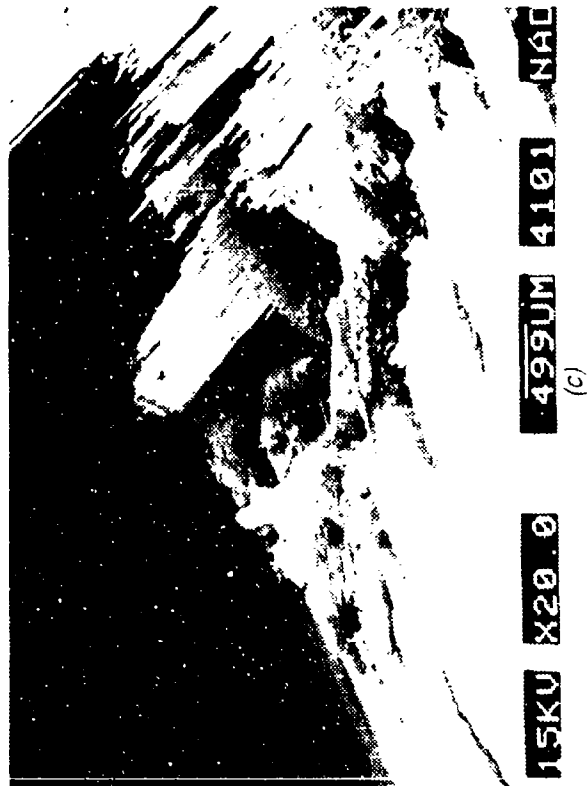
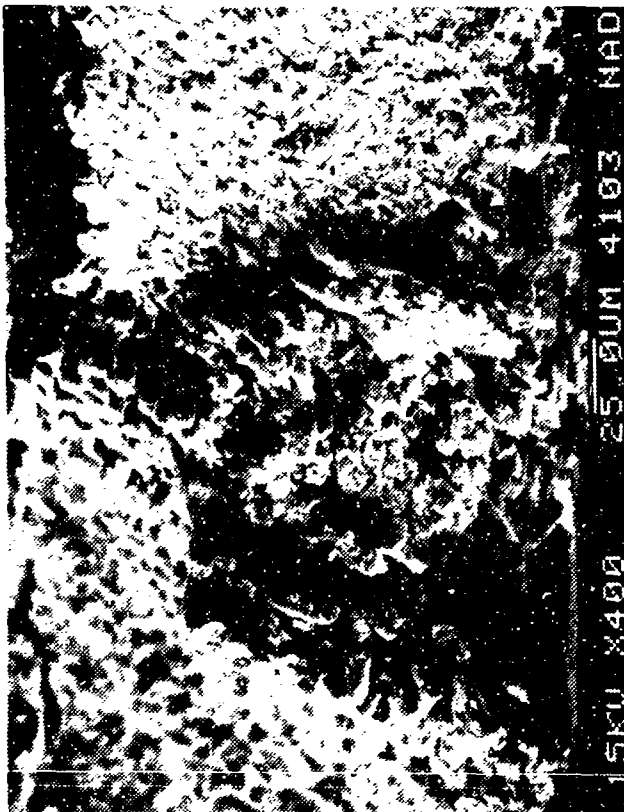
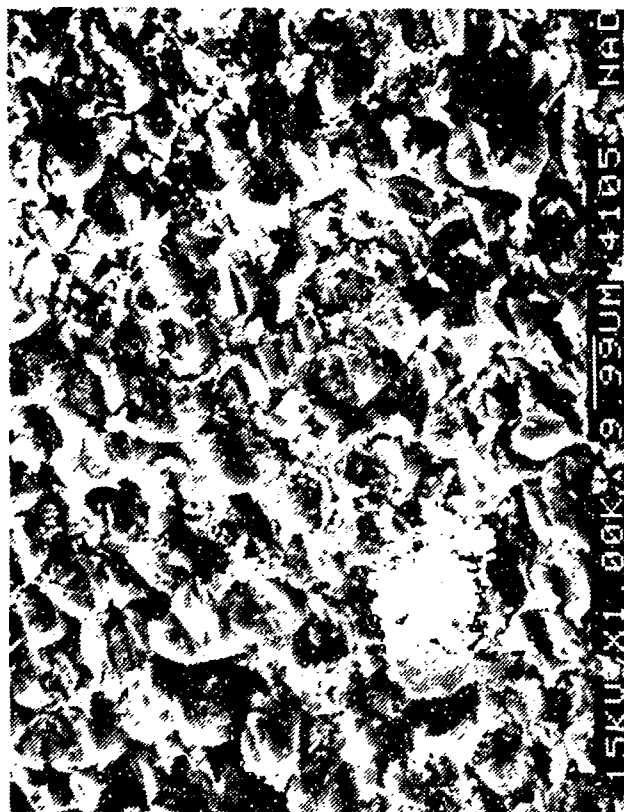
Figure 2-172. Optical and SEM Photographs of Translaminar Mode I Compression Fracture in Overcured Gr/Ep - 32 P/ly Quasi-Isotropic
(a) Macro photograph of fractured fragments
(b), (c) Normal and Oblique Views of Fracture Near the Apex

CD = Crack propagation direction

Figure 2-172. (Continued)
 (d) Microbuckling Features (Chop Marks) on Fractured Fiber Ends
 (e) Broken Fibers
 CD = Crack-propagation direction

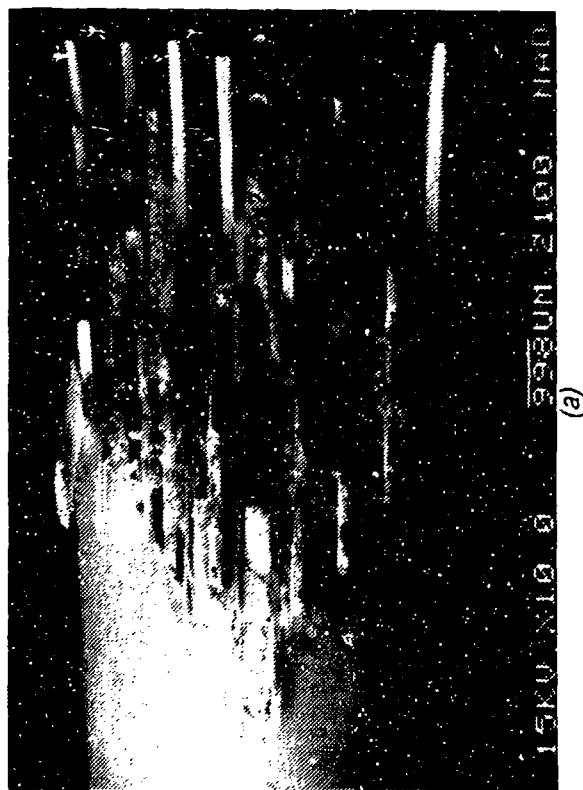
Figure 2-173. Optical and SEM Photographs of Translaminar Mode I Compression Fracture in High Resin Content Gr/Ep - 32 Ply Quasi-Isotropic

(a) Macro photograph of the Fracture and Apex

(b) Fracture Near the Apex

Note the flat fracture surface and the post fracture damage

CD = Crack propagation direction

Figure 2-173. (Continued)
 (d) Flexural Fracture Features
 Note: Chop marks (C) on individual fiber ends are typical of flexural fractures in compression.
 (e) Hackles (H) and Scallops (S) in a 90 Degree Ply
 (f) Multiple Fiber Breaks Due to Microbuckling

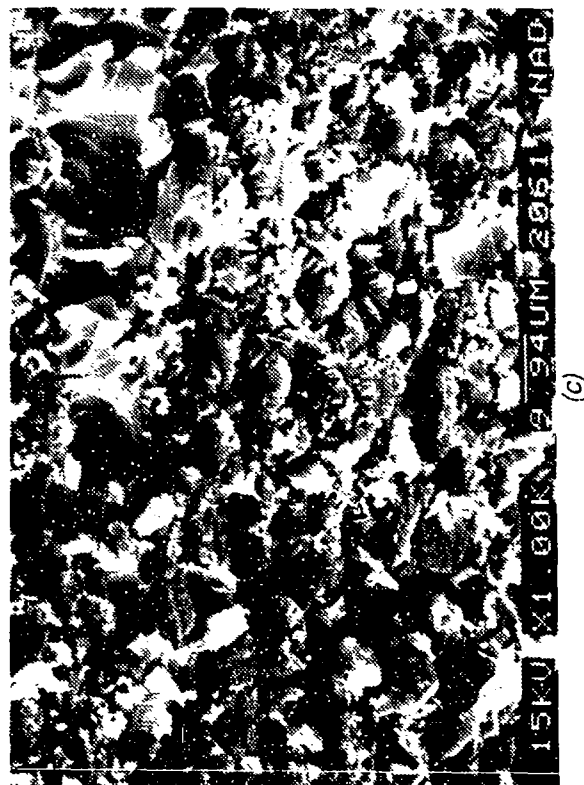
(c) High Magnification of (b) Showing Crushed Fibers

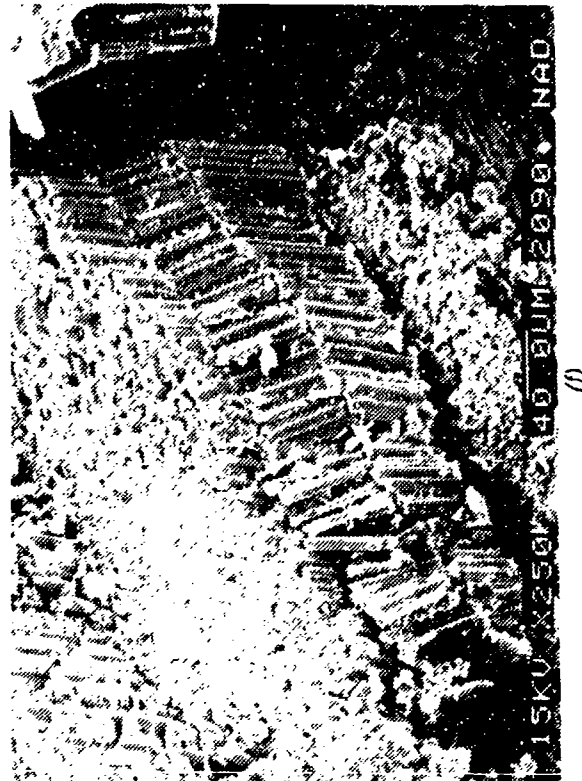
CD = Crack propagation direction

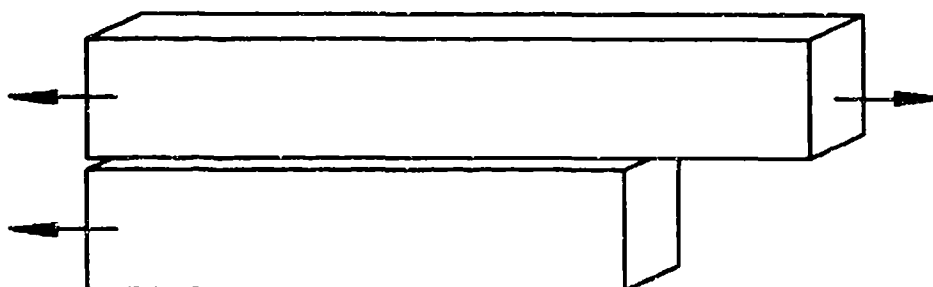
Figure 2-174. Side-Notched Rail Shear Type Test

As with compression dominated fractures, fractographic features by which the direction of fracture can be identified, do not exist. Figure 2-174 shows the side-notched rail shear test configuration and Table 2-7 provides the test matrix for the translaminar shear testing. Figures 2-175 through 2-184 are the corresponding fractographs.

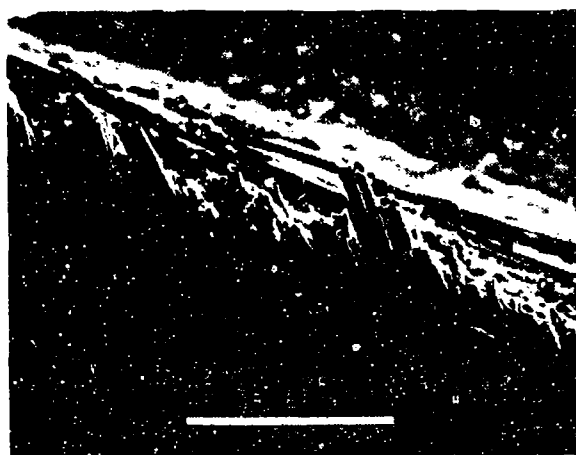
Fracture type	Translaminar mode II shear
Ply layup	[0, 90] _{16S}
Test type	Side-notched rail shear
• Test conditions	Dry
• Fiber end fracture	
Material	Hercules 3501-6/177°C cure AS4 fibers

Figure 2-176. SEM Photographs of Translaminar Mode II Shear, 0/90 Fracture, -65, 180, 270 F/Dry (400X)

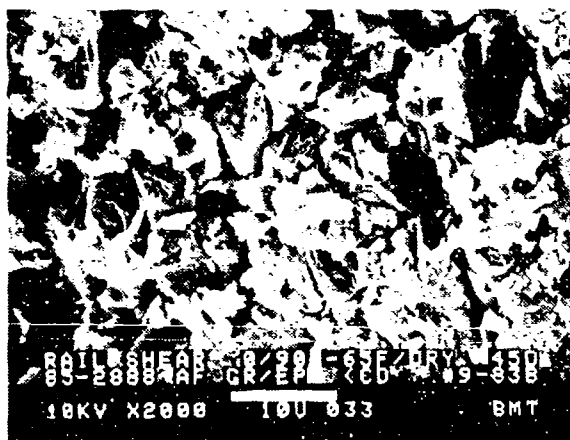
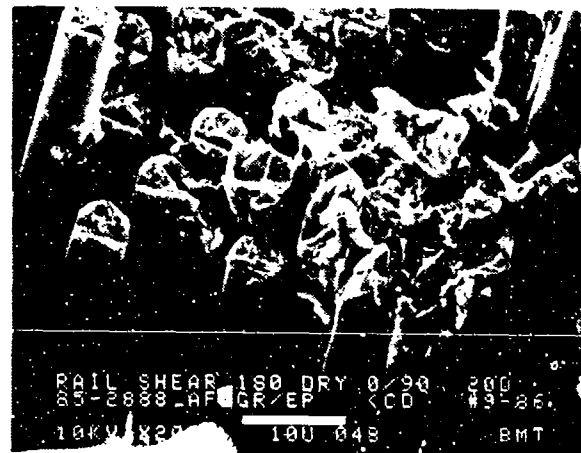
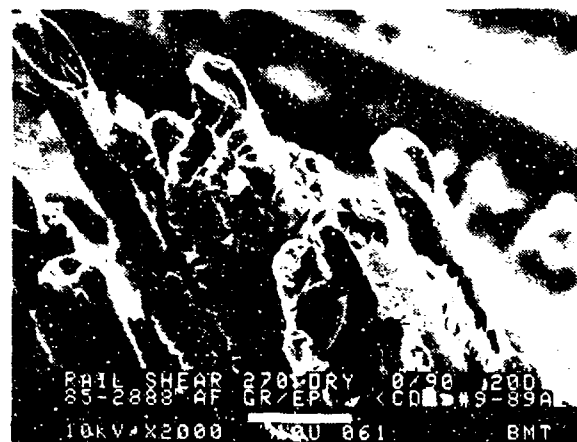
Fracture type	Translaminar mode II shear
Ply layup	[0, 90] ₁₆ S
Test type	Side-notched rail shear
• Test conditions	Dry
• Fiber end fracture	
Material	Hercules 3501-6/177°C cure AS4 fibers

Figure 2-177. SEM Photographs of Translaminar Mode II Shear, 0/90 Fracture, -65, 180, 270 F/Dry (2000X)

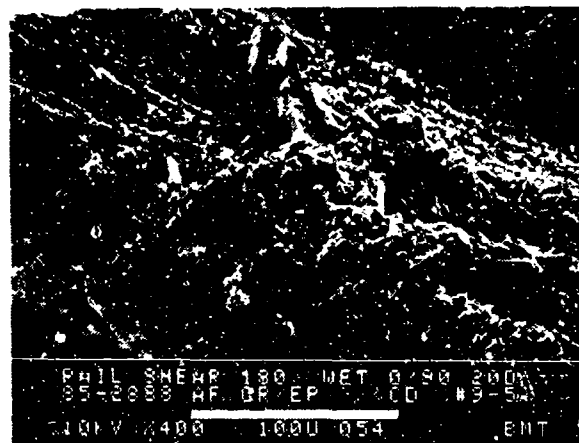
Fracture type	Translaminar mode II shear
Ply layup	[0, 90] _{16S}
Test type	Side-notched rail shear
• Test conditions	Wet
• Fiber end fracture	
Material	Hercules 3501-6/177°C cure AS4 fibers

Figure 2-178. SEM Photographs of Translaminar Mode II Shear, 0/90 Fracture, 70, 180, 270 F/Wet (400X)

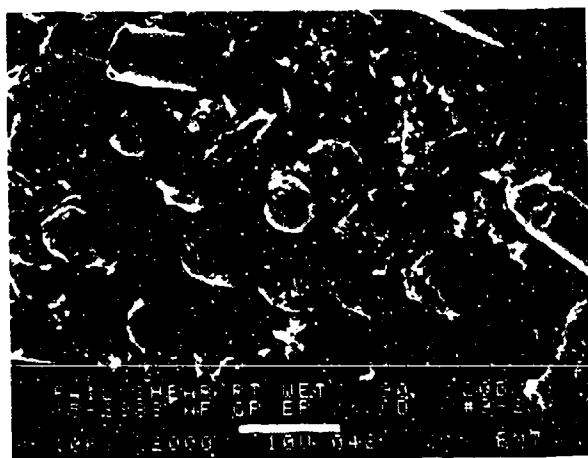
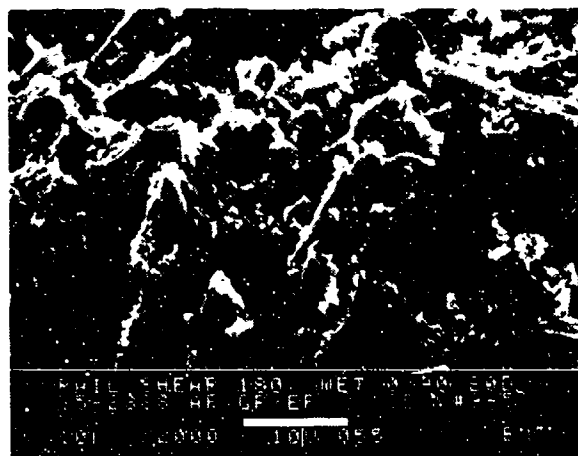
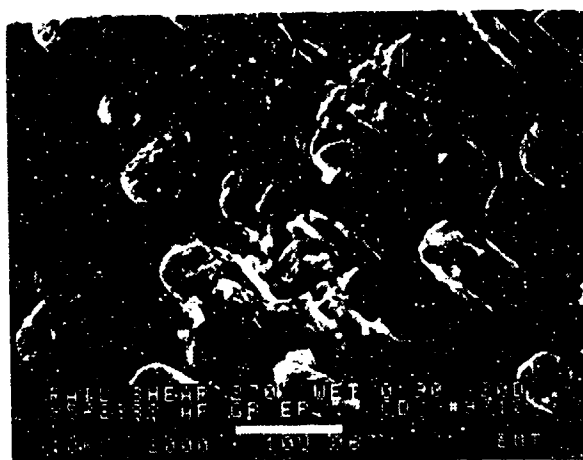
Fracture type	Translaminar mode II shear
Ply layup	[0, 90] _{16S}
Test type	Side-notched rail shear
• Test conditions	Wet
• Fiber end fracture	
Material	Hercules 3501-6/177°C cure AS4 fibers

Figure 2-179. SEM Photographs of Translaminar Mode II Shear, 0/90 Fracture, 70, 180, 270 F/Wet (2000X)

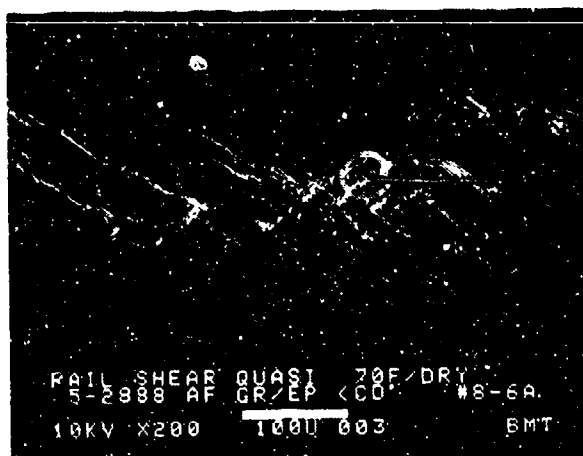
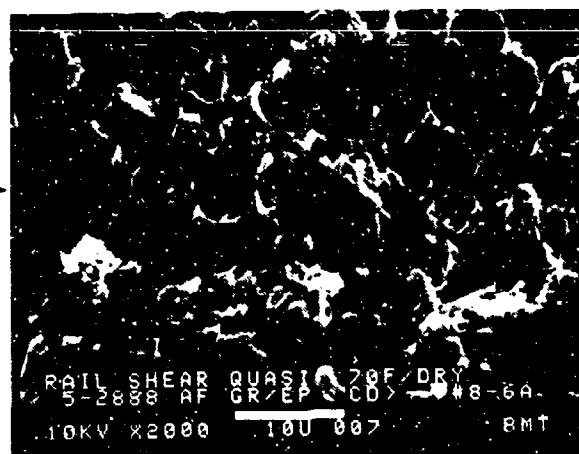
Fracture type	Translaminar mode II shear
Ply layup	[0, 45, 90] _{16S}
Test type	Side-notched rail shear
• Test conditions	21°C, dry
• Fiber end fracture	
Material	Hercules 3501-6/177°C cure AS4 fibers

Figure 2-180. SEM Photographs of Translaminar Mode II Shear, 0/45/90 Fracture, 70 F/Dry

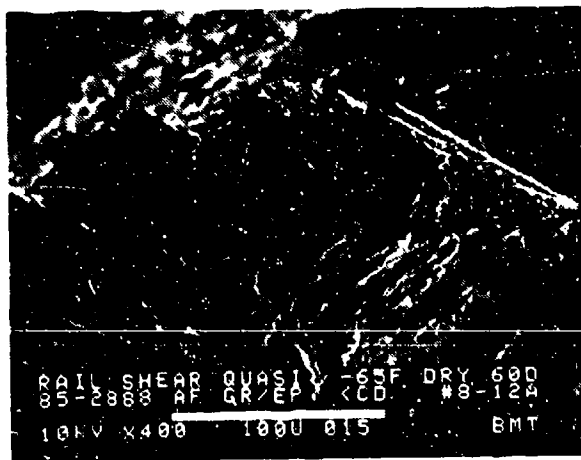
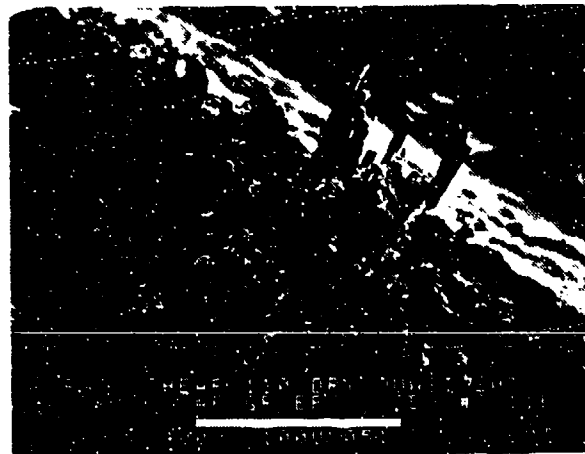
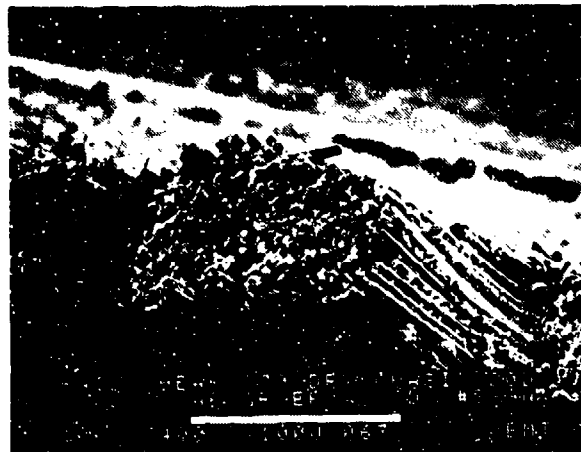
Fracture type	Translaminar mode II shear
Ply layup	[0,45, 90] _{16S}
Test type	Side-notched rail shear
• Test conditions	Dry
• Fiber end fracture	
Material	Hercules 3501-6/177°C cure AS4 fibers

Figure 2-181. SEM Photographs of Translaminar Mode II Shear, 0/45/90 Fracture, -65, 180, 270 F/Dry (400X)

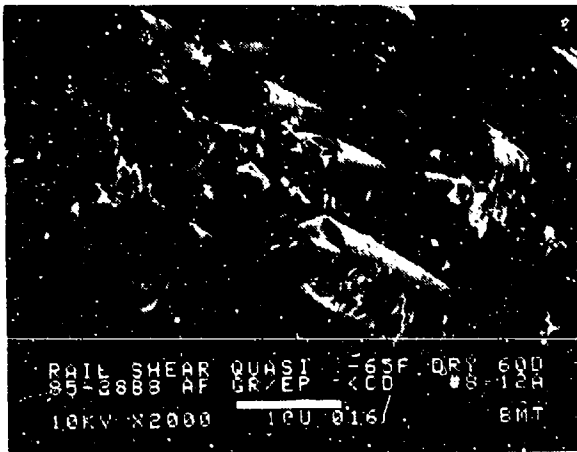
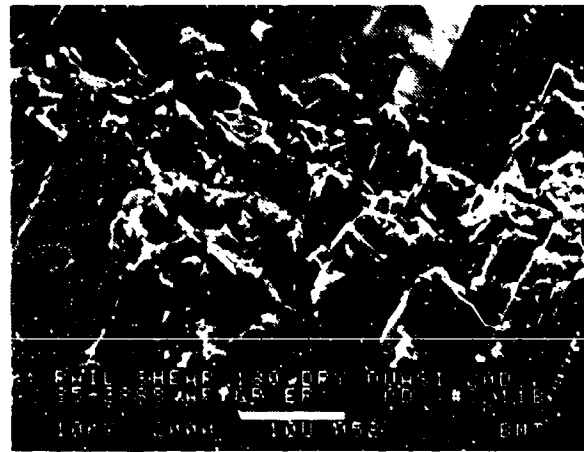
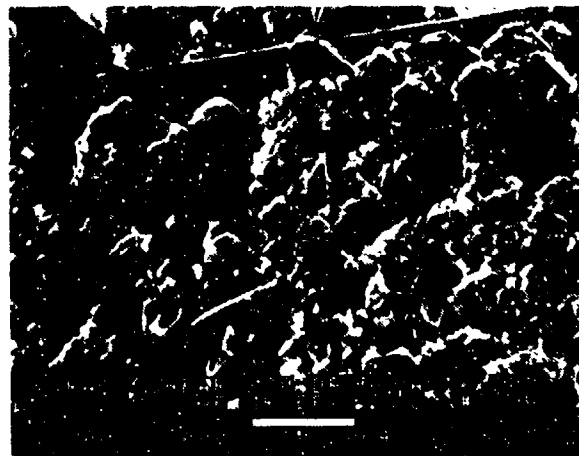
Fracture type	Translaminar mode II shear
Ply layup	[0, 45, 90] _{1,2,3} S
Test type	Side-notched rail shear
• Test conditions	Dry
• Fiber end fracture	
Material	Hercules 3501-6/177°C cure AS4 fibers

Figure 2-182. SEM Photographs of Translaminar Mode II Shear, 0/45/90 Fracture, -65, 180, 270 F/Dry (2000X)

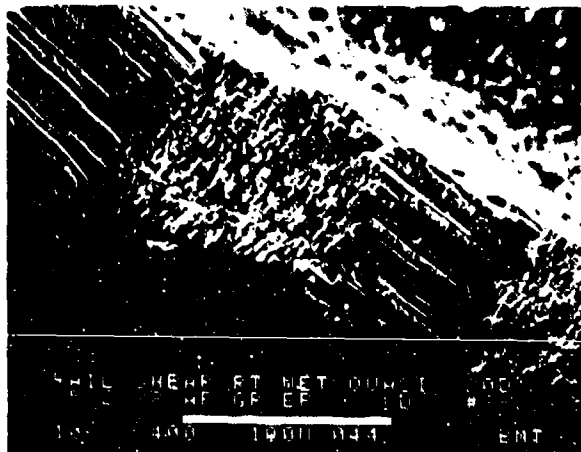
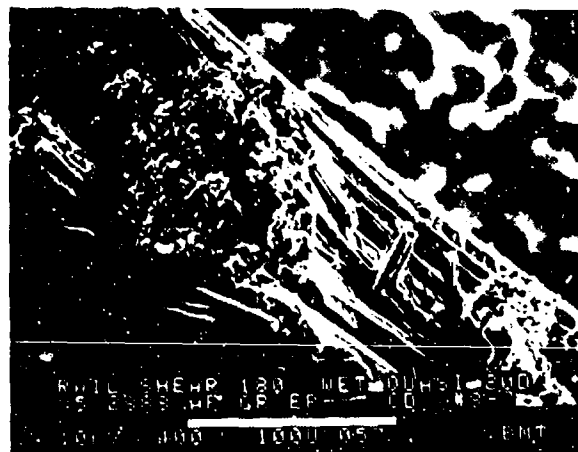
Fracture type	Translaminar mode II shear
Ply layup	[0, 45, 90] 16S
Test type	Side-notched rail shear
• Test conditions	Wet
• Fiber end fracture	
Material	Hercules 3501-6/177°C cure AS4 fibers

Figure 2-183. SEM Photographs of Translaminar Mode II Shear, 0/45/90 Fracture, 70, 180, 270 F/Wet (400X)

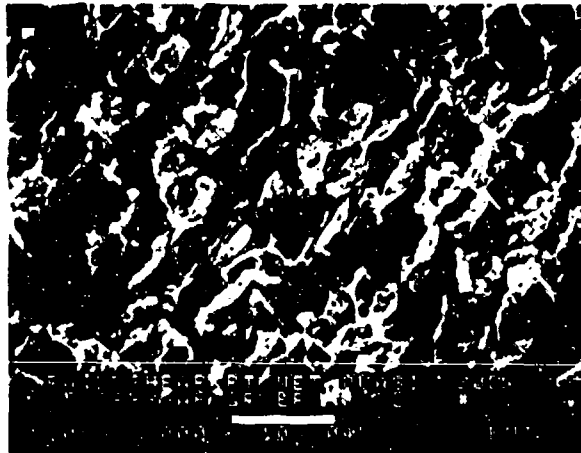
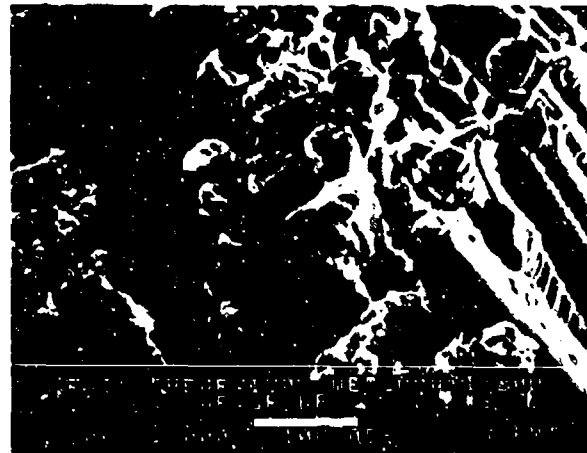
Fracture type	Translaminar mode II shear
Ply layup	[0, 45, 90] _{16S}
Test type	Side-notched rail shear
• Test conditions	Wet
• Fiber end fracture	
Material	Hercules 3501-6/177°C cure AS4 fibers

Figure 2-184. SEM Photographs of Translaminar Mode II Shear, 0/45/90 Fracture, 70, 180, 270 F/Wet (2000X)

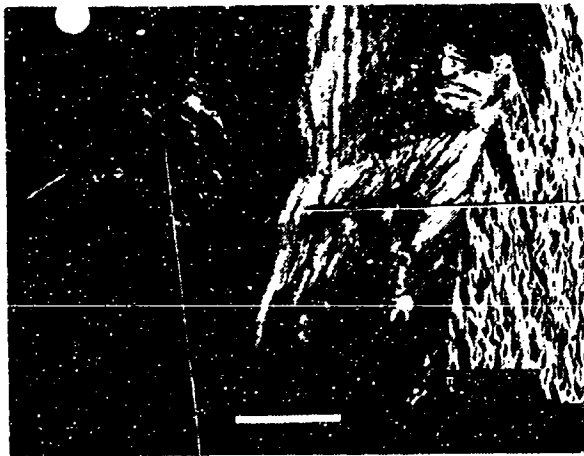
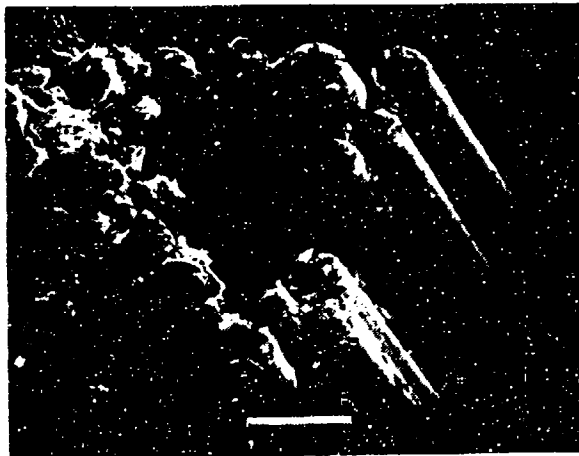
Fracture type	Translaminar flexure
Ply layup	[0] ₃₂
Test type	Laminate flexure
• Test conditions	20°C, dry
• Fiber end fracture	
Material	Hercules 3501-6/177°C cure AS4 fibers

Compression Fracture Region

Tensile Fracture Region

Figure 2-186. SEM Photographs of Translaminar Flexure, 0/0 Fracture, 70 F/Dry

The primary features observed in unnotched specimens which fail because of flexural loading are as follows:

1. Macroscopic identification of rough (tensile) and smooth (compressive) fracture regions
2. Distinct separation between tension and compression regions (as indicated by a neutral axis region)
3. Tensile fractures tend to initiate along the outer surface and progress toward the neutral line (as indicated by analysis of fiber end radials).

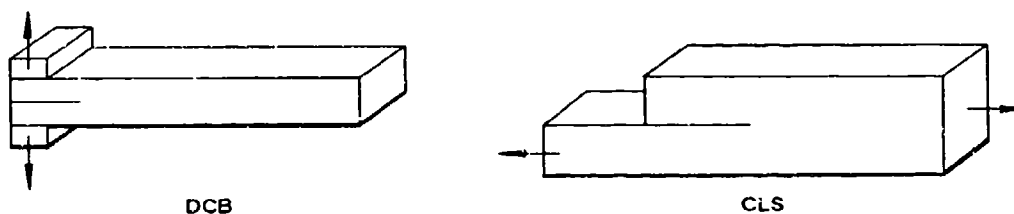
Figure 2-187. Double Cantilever Beam (DCB) for Mode I Fractures and Cracked-Lap Shear (CLS) for Mode II Fractures

Figure 2-187 shows the test configuration of double cantilever beam (DCB) for Mode I fractures and cracked-lap shear (CLS) for Mode II fractures. Figures 188, 189 and 190 are Mode I DCB constant amplitude fatigue fractographs contributed by Boeing. Figures 191, 192 and 193 are Mode I DCB variable amplitude (Spectrum) fatigue fractographs contributed by Northrop. Figures 194 through 197 are Mode II CLS constant amplitude fatigue fractographs contributed by Boeing.

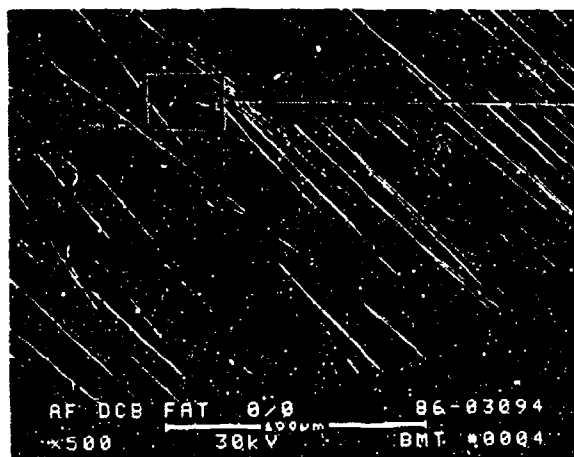
Fracture type	Interlaminar fatigue mode I tension
Ply layup	[0]24
Test type	Fatigue DCB
• Test conditions	21°C, dry
• Fracture between	0/0 plies
Material	Hercules 3501-6/177°C cure AS4 fibers

Mechanically Induced crack direction

Figure 2-190. SEM Photographs of Interlaminar Fatigue Mode I Tension, 0/0 Fracture, 70 F/Dry (500X and 5000X)

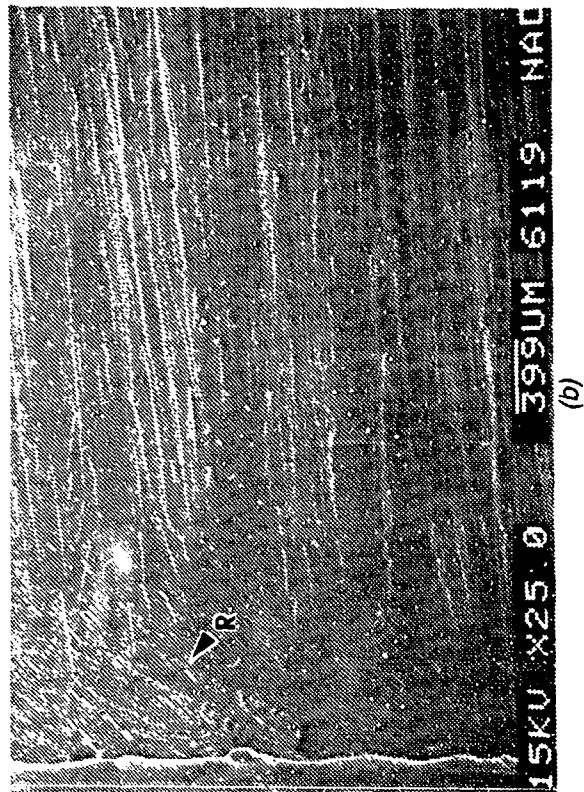
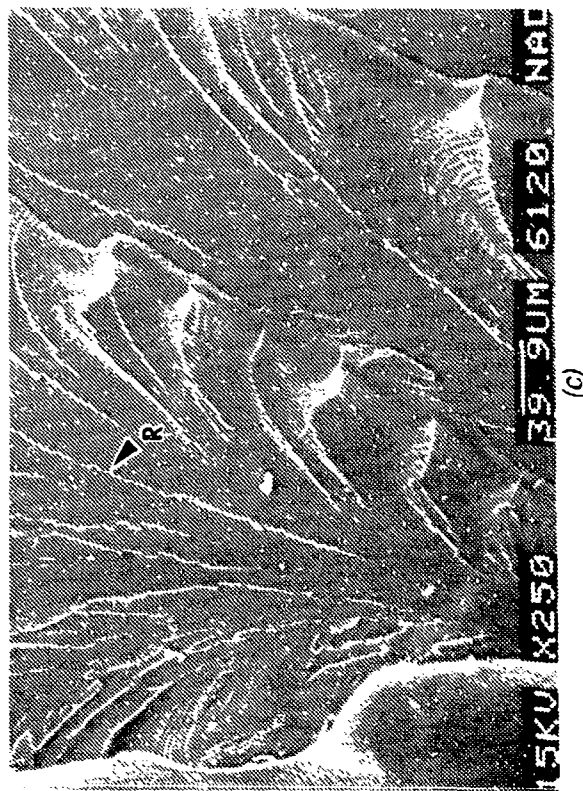
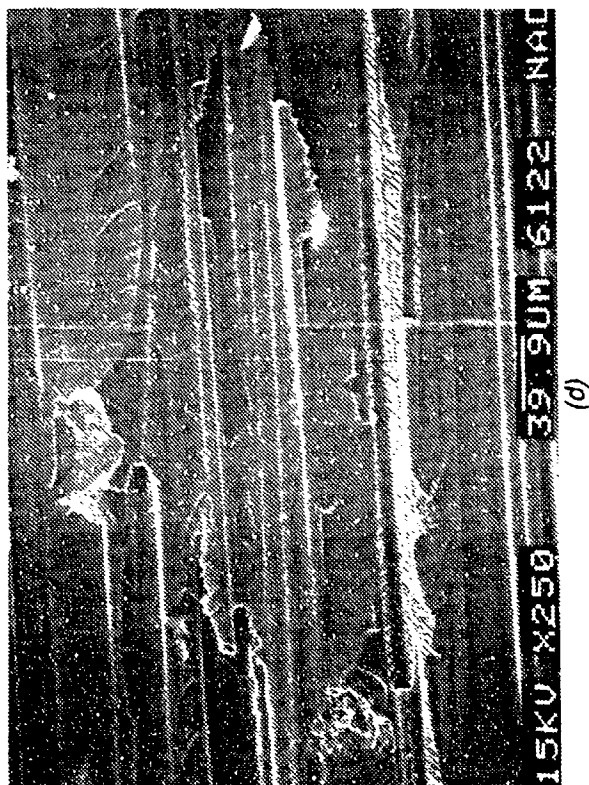
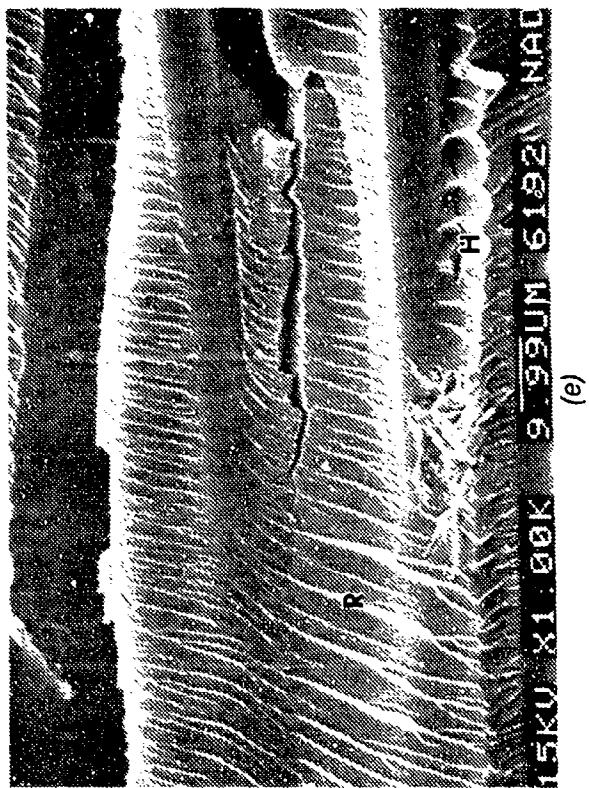
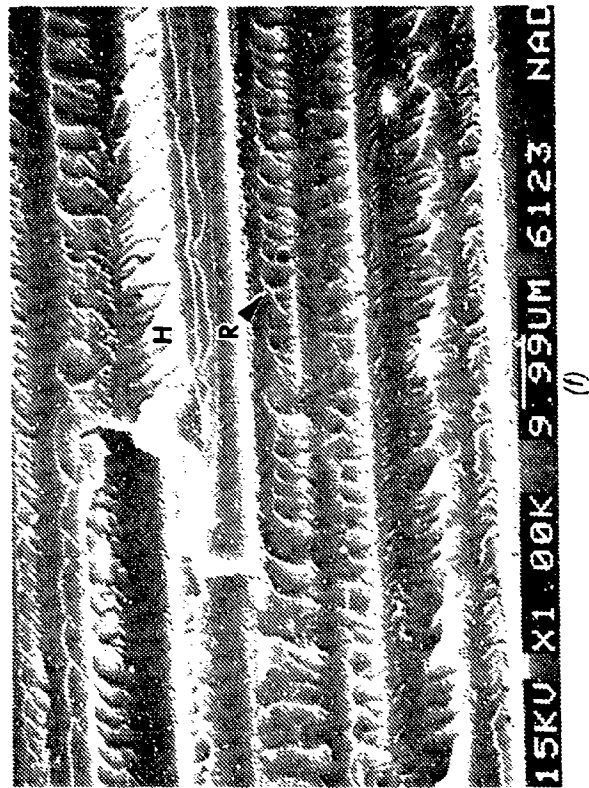
Figure 2-191. Optical and SEM Photographs of Interlaminar Mode I DCB Spectrum Fatigue Fracture in AS4/3501-6 Gr/Ep - [0]_{24T}
 (a) Macro photograph
 (b), (c) Initiation in Resin Rich Areas

Figure 2-191. (Continued)
 (d) Low Magnification Photograph of Crack Growth
 Region
 Note regular arrangement of river patterns and occasional hackles
 (e), (f) Fracture Details

CD = Crack-propagation direction
 H = Hackles
 R = River patterns
